Assessment of Building by Non-Destructive Test

The aim of this work to present Condition Assessment and Structural Audit of Gokulpeth Market NIT Building at Nagpur (Maharashtra)

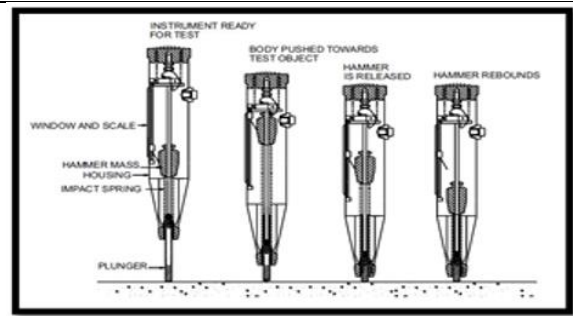
Figure 3: As per IS 13311 Part II

1. This test is a non-destructive concrete test that provides a simple and fast indication of the compressive strength of concrete. A rebound hammer consists of a controlled mass spring that slides on a piston inside a tubular body.
2. Check the compressive strength of concrete by relating the restitution index to the compressive strength.
3. Check whether the concrete is evenly distributed. Based on the standard specification to examine the properties of concrete.
4. To co-related concrete elements with one another in consideration of quality

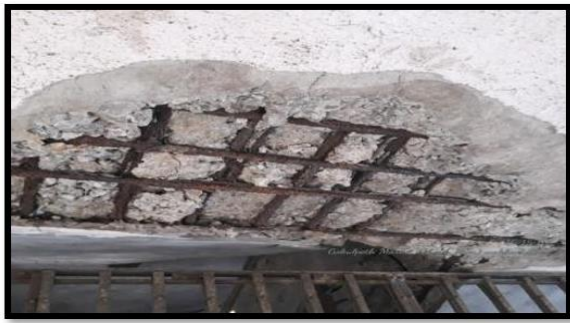
Figure 5: Reinforcement exposed and concrete damage

Location: -Grid 27 to 29 CD back passage in front of stair slab
 Observation: -Reinforcement exposed, concrete damage, crack observed.
 Level of criticality: - High
 Remedial Measures: - Dilapidated Condition

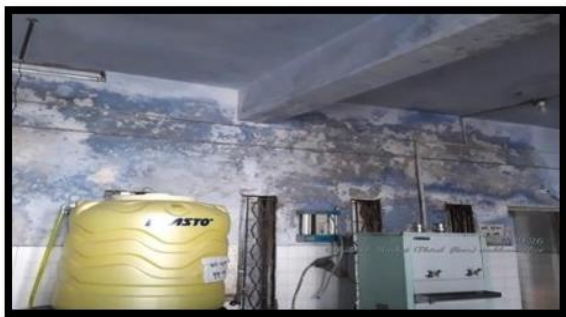
Figure 6: Seepage in wall

Location: -Grid 8-9 BC wall between B7 to B9
 Observation: -Seepage
 Level of criticality: - High
 Remedial Measures: - Dilapidated Condition

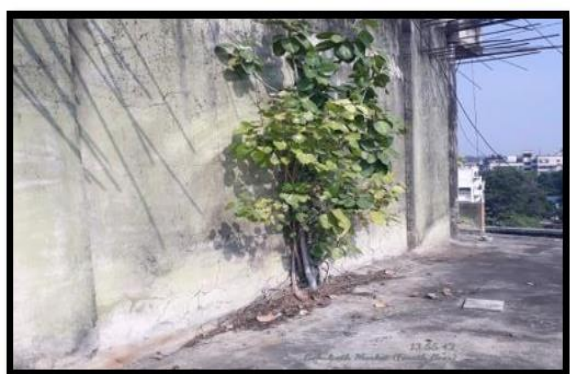
Figure 7: Vegetation Growth on structure

Location: -Wall between 18AB
 Observation: -Vegetation Growth
 Level of criticality high
 Remedial Measures: - Dilapidated Condition
